SHC 2015, International Conference on Solar Heating and Cooling for Buildings and Industry

Performance evaluation of lighting and daylighting retrofits: results from IEA SHC task 50

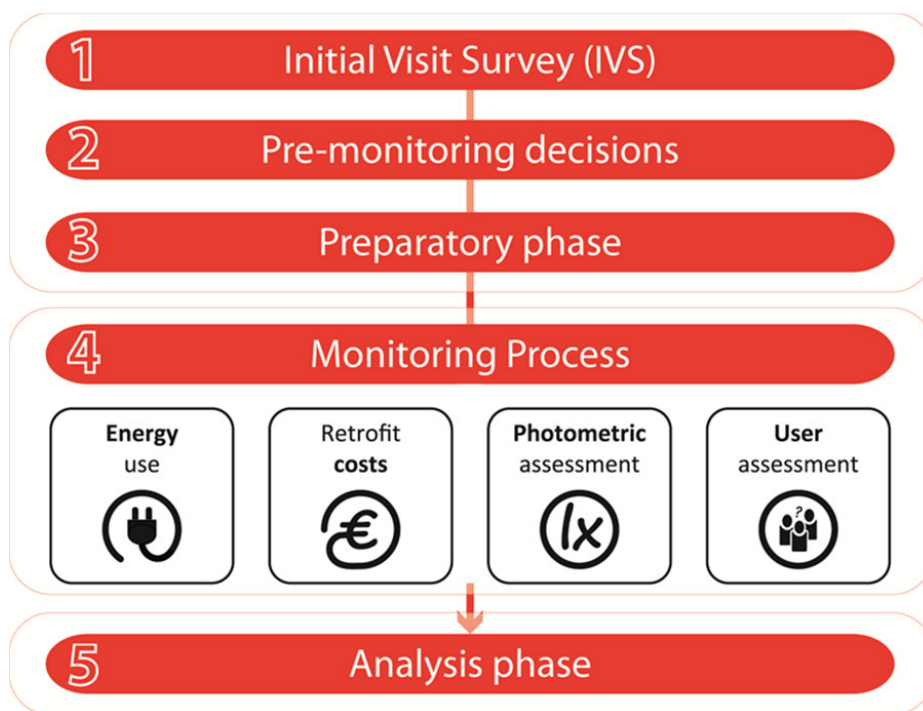
Fig. 2. Structure of the monitoring protocol.

The access to monitored data is crucial to assess whether daylighting or electric lighting systems deliver the anticipated performance in terms of energy efficiency, cost-effectiveness, and lighting quality. The monitoring protocol [1] developed as part of Subtask D is a toolbox for professionals including a five-phase procedure for preparing and conducting the lighting retrofit assessment. After a general introduction, five phases are covered in separate chapters in the monitoring protocol document, which measures four fundamental aspects of a lighting retrofit project (Energy use, Retrofit costs, Photometric assessment, User assessment), as outlined in Fig. 2.

The section about energy use and retrofit costs basically involve the collection of information on costs, the description of daylight/electric lighting systems and, when possible, the measurements of energy consumption. The photometric assessment, which is the most developed part of the protocol, involves measurements of seven key photometric quantities that allow describing lighting conditions and quality, see [2] for details. Finally, the fourth aspect of the protocol called ‘User assessment’ involves subjective assessments via questionnaires and/or interviews with the building occupants.

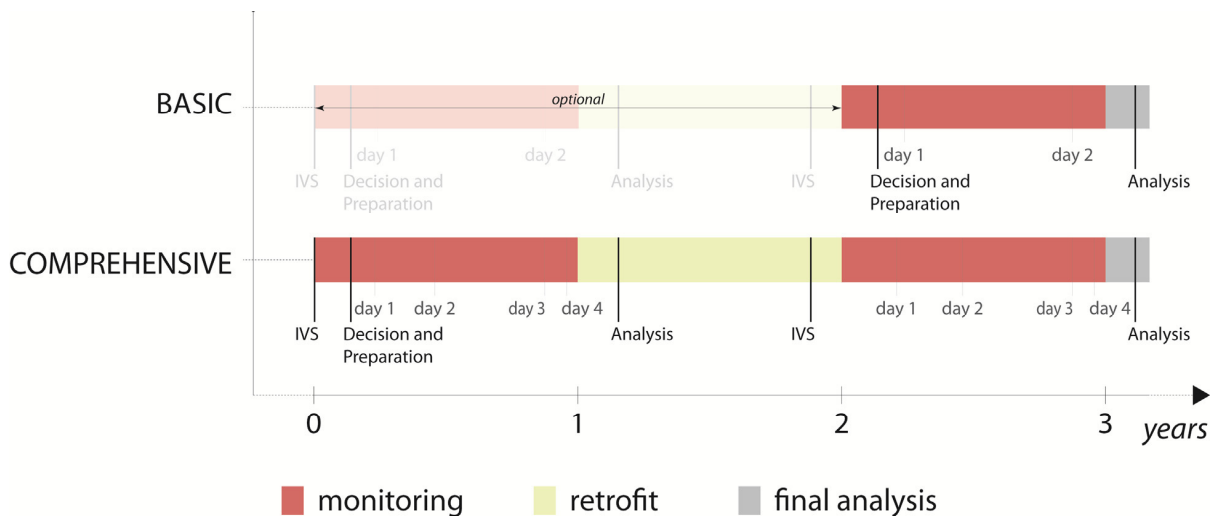
Fig. 3. Timeline for the evaluation for the two different levels of monitoring.

The protocol offers two monitoring levels: 1) a ‘basic’ and 2) a ‘comprehensive’ level. The choice depends on the purpose of monitoring and on practical constraints like the access to the building and the availability of resources. The protocol is developed so that a comprehensive picture of the electric lighting/daylighting performance can be obtained for the conditions before and after renovation (referred to as pre- and post-retrofit in the monitoring protocol document). However, it is possible to use segments of the protocol. For example, in some cases, it is not possible to access the pre-retrofit situation as the building has already been retrofitted. In this case, it is possible to perform the post-retrofit evaluation only and compare the results obtained with typical (benchmark) values for similar types of spaces.

The ‘basic’ level requires a) more limited instrumentation, b) access to the spaces at least in their post-retrofit condition, c) an overcast sky day and clear sky day (close to an equinox) over a one-year period for the actual monitoring, d) approximately one year for the whole evaluation process (Fig. 3). On the other hand, the ‘comprehensive’ level requires a) advanced instrumentation, b) access to the spaces both before and after the retrofit, c) four days per year over a period of two years for the actual monitoring (overcast day, clear skies for an equinox and each solstice), d) approximately three years for the whole evaluation process. Note also that it is possible to mix elements of the basic and comprehensive monitoring procedure to suit the specific needs of the building or monitoring team.
